Title T-Jam 45		
Author M. Broek TDS & MBE		
File U:\tubeamps\mbse\T-Jam45\T-Jam45.dsn	Document Preamp	
Revision 1.1	Date 05-Oct-2010	Sheets 1 of 6

Title T-Jam 45		
Author M. Broek TDS & MBE		
File U:\tubeamps\mbse\T-Jam45\T-Jam45.dsn	Document OD	
Revision 1.1	Date 05-Oct-2010	Sheets 2 of 6

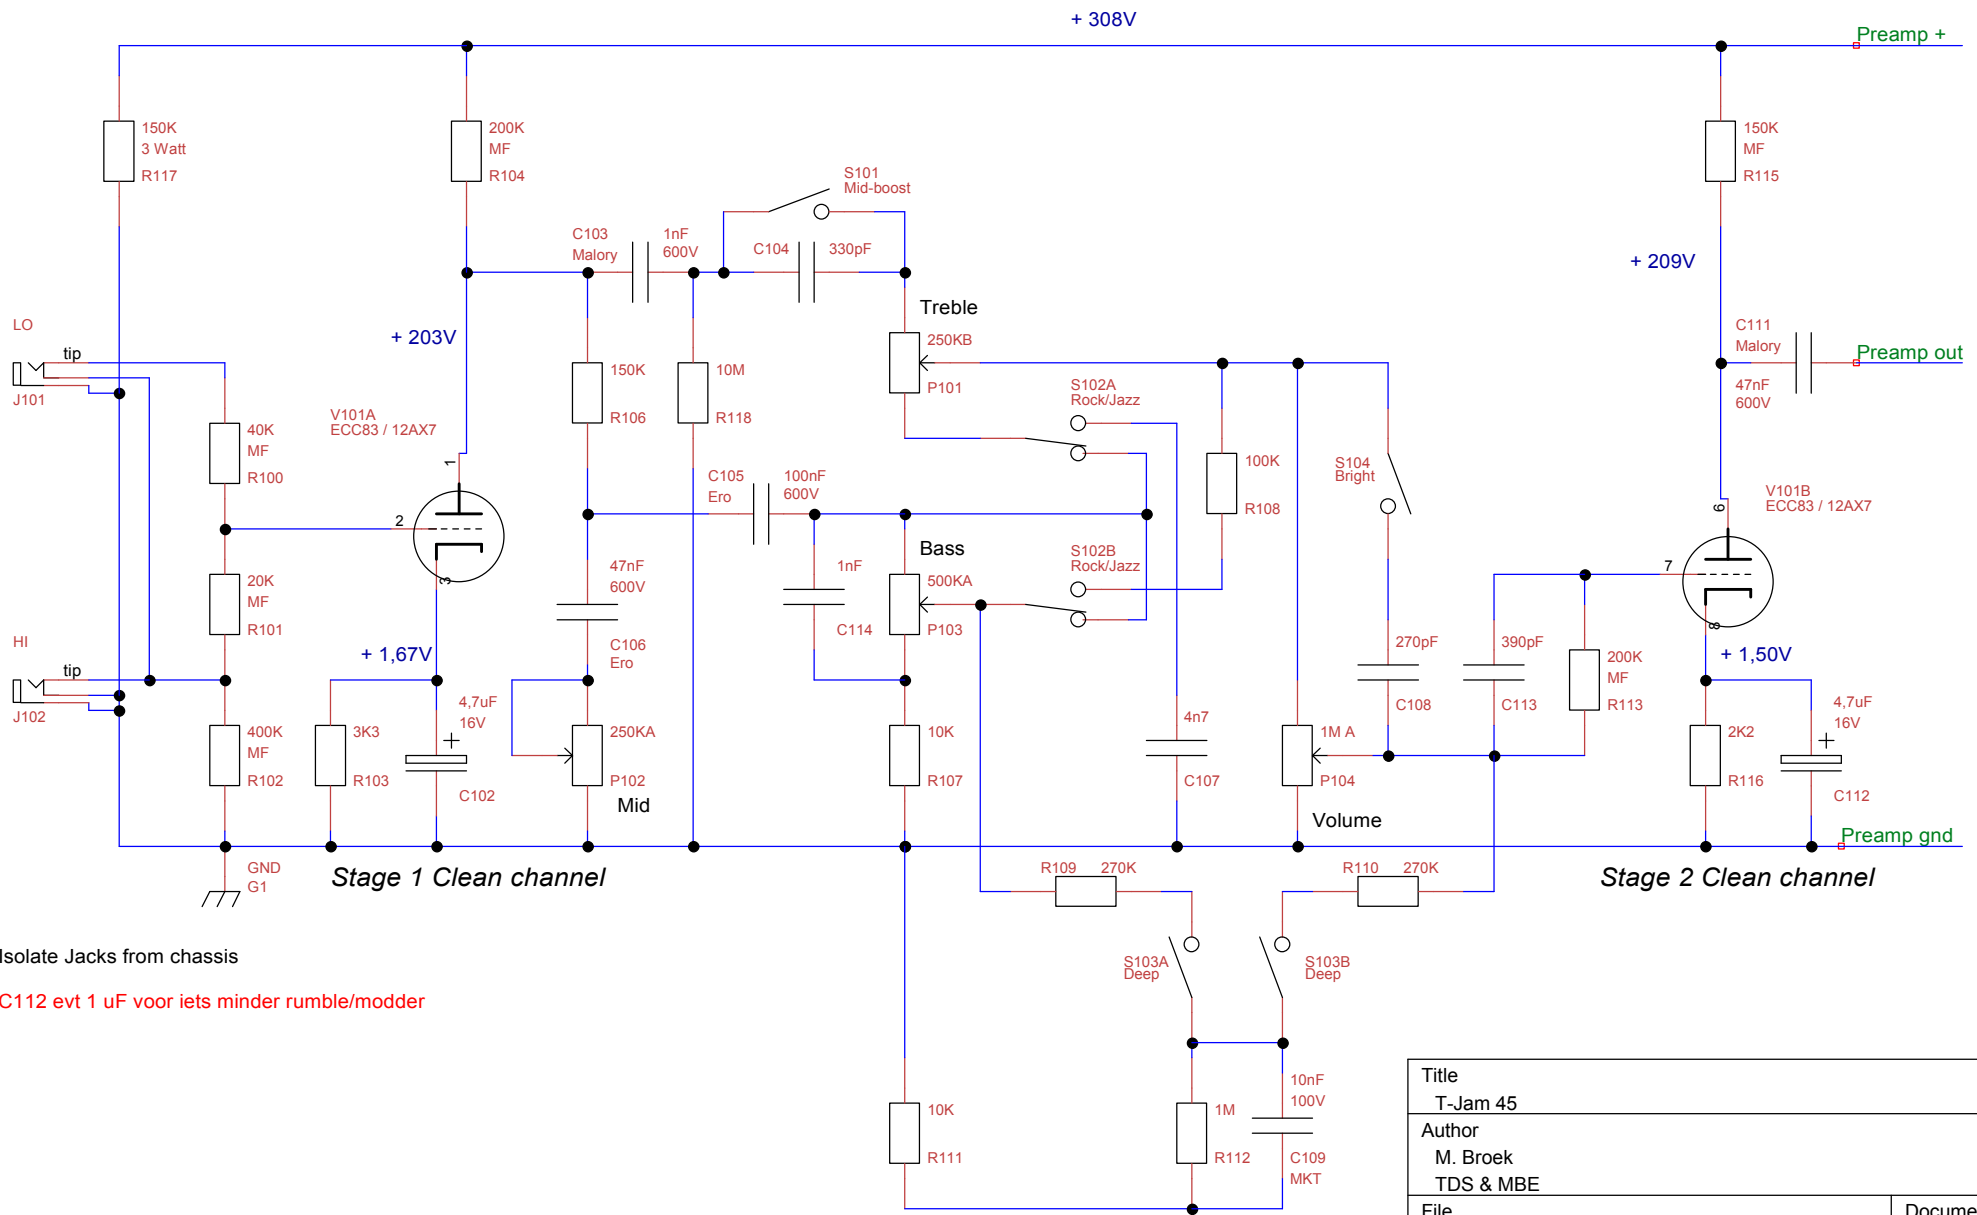
Isolate Jacks from chassis

C112 evt 1 uF voor iets minder rumble/modder
